**National Hydropower Association
Operational Excellence
Event Report**

1) Submitting Organization: Redacted		2) Name of Preparer, Phone & Email: Redacted		3) Report Number (OE Internal Use): To Be Supplied Later	
4) Date & Time of Event: February 12, 2011, 13:20		5) Duration of Event: From 13:20 to 22:05		6) Functional Area: Environmental	
				7) Functional Area Subclass: Oil Release to Environment	
8) Classification Minor <input type="checkbox"/> Significant <input checked="" type="checkbox"/> Severe <input type="checkbox"/>		9) Impact of Event: Hydraulic Oil was release to the tail water below hydro plant		10) Human Performance: Was the event the result of inappropriate actions? No

Alpha Hydro Plant

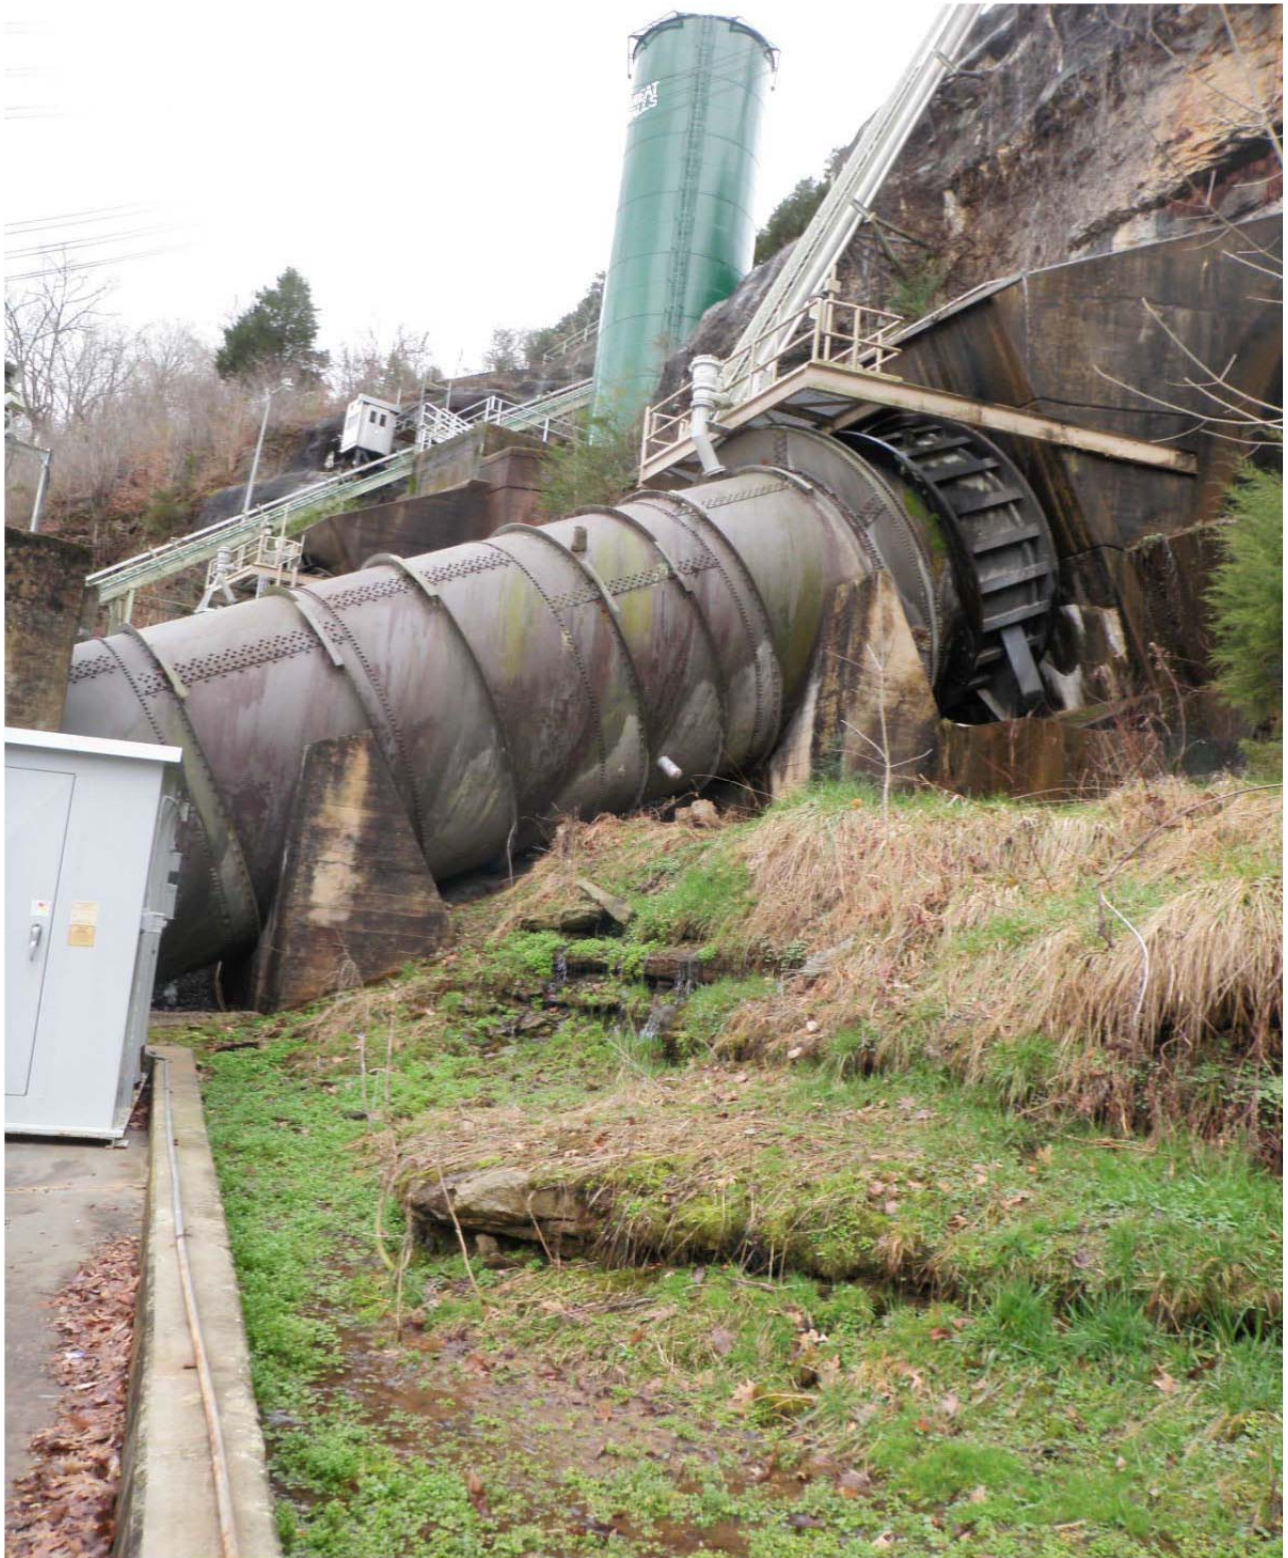
- AHP Units 2 Penstock butterfly valve hydraulic operated cylinder front seal failure due degradation, and environmental conditions.

General view of Penstocks and Butterfly Valves

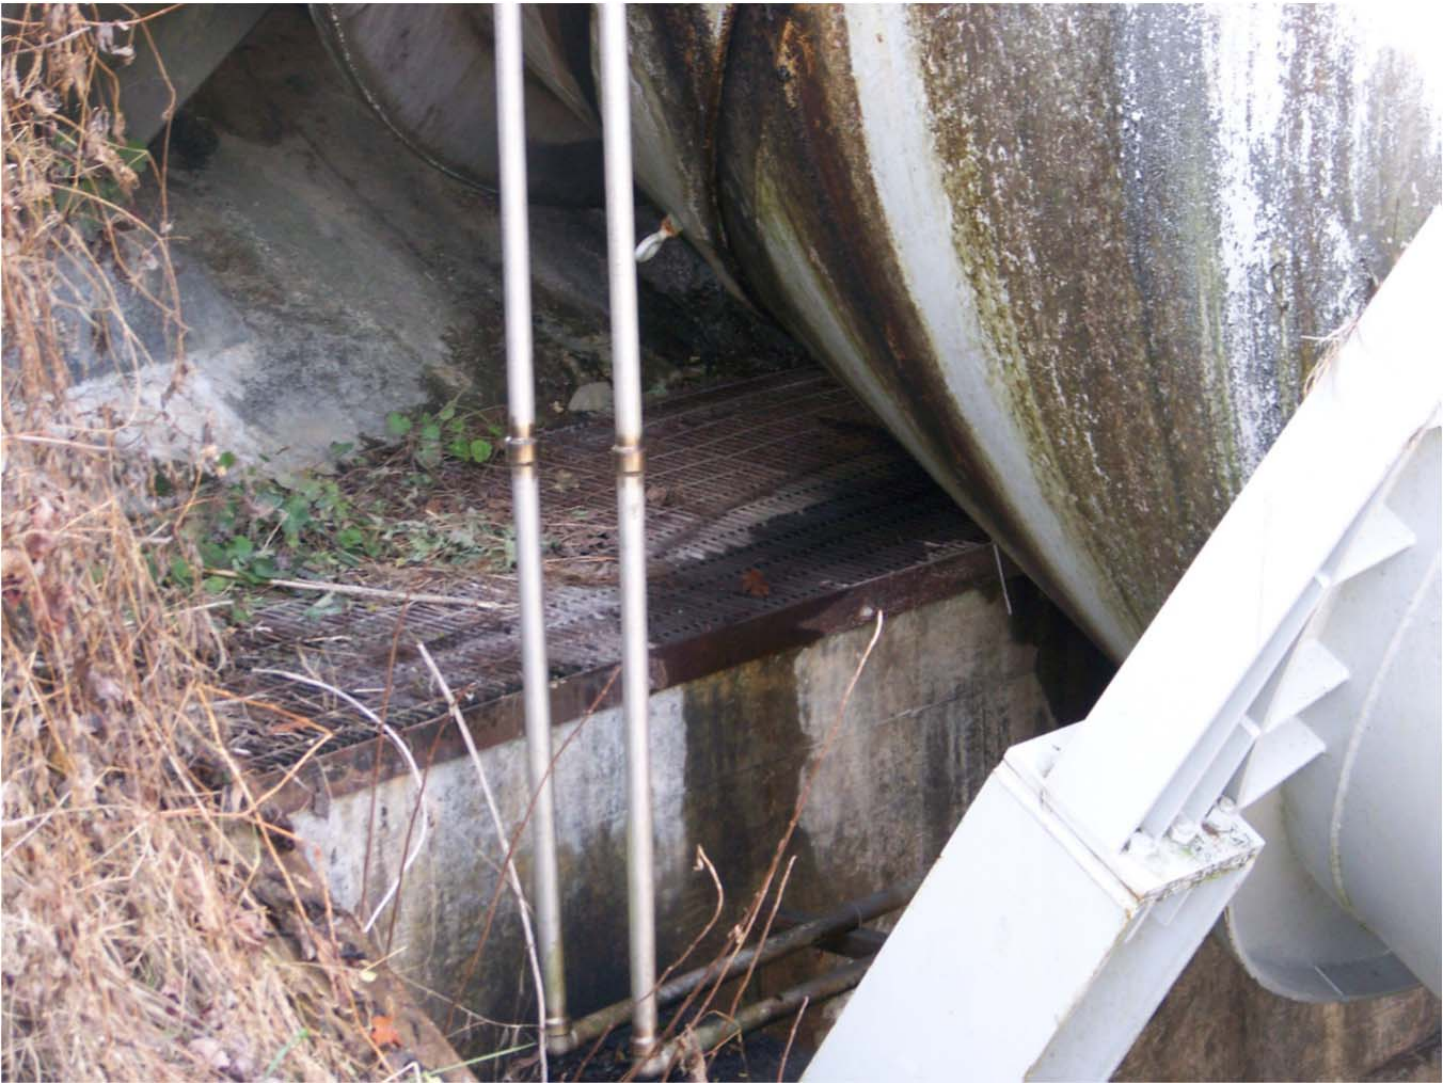
- Poor design and possible dysfunctional oil/water separator contributes to flapper valve being stuck.
- AHP Units 1 penstock butterfly valve hydraulic operated cylinder showing signs of degradation and some leakage.

Unit 1 Penstock Butterfly Valve Foot and Oil Leakage into Storm Drains
